PROPERTY & LIABILITY INSPECTION

March 2012

**PREPARED FOR
West Hills Community College**

KEENAN & ASSOCIATES
2882 Prospect Park Dr. Suite 200
Rancho Cordova Ca. 95670

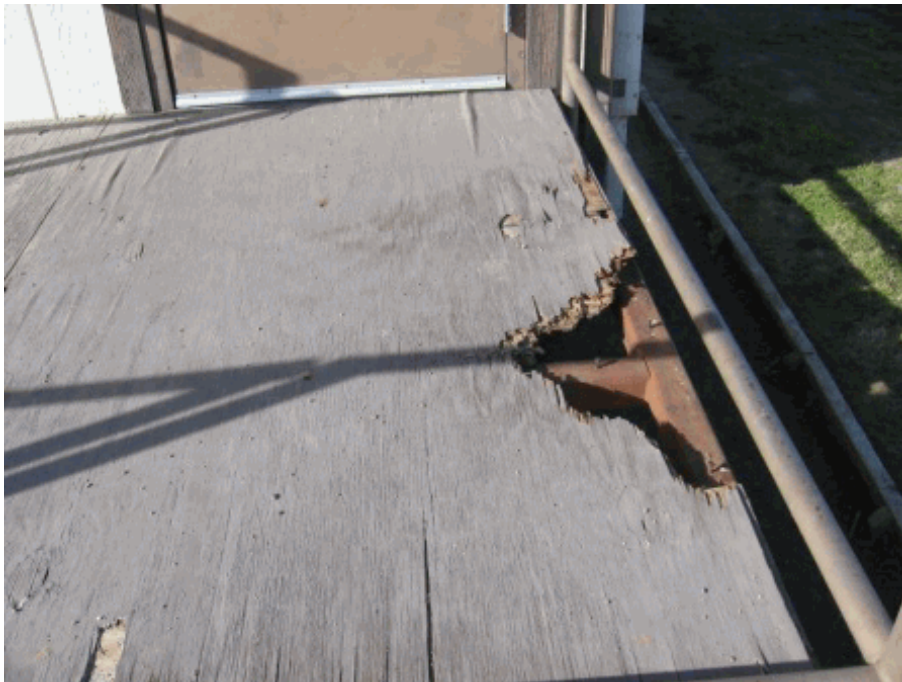
Portable 21

The wood ramp of the portable classroom was worn through. The wood ramp should be repaired or replaced to eliminate the slip/fall hazard that was observed.

Priority: High

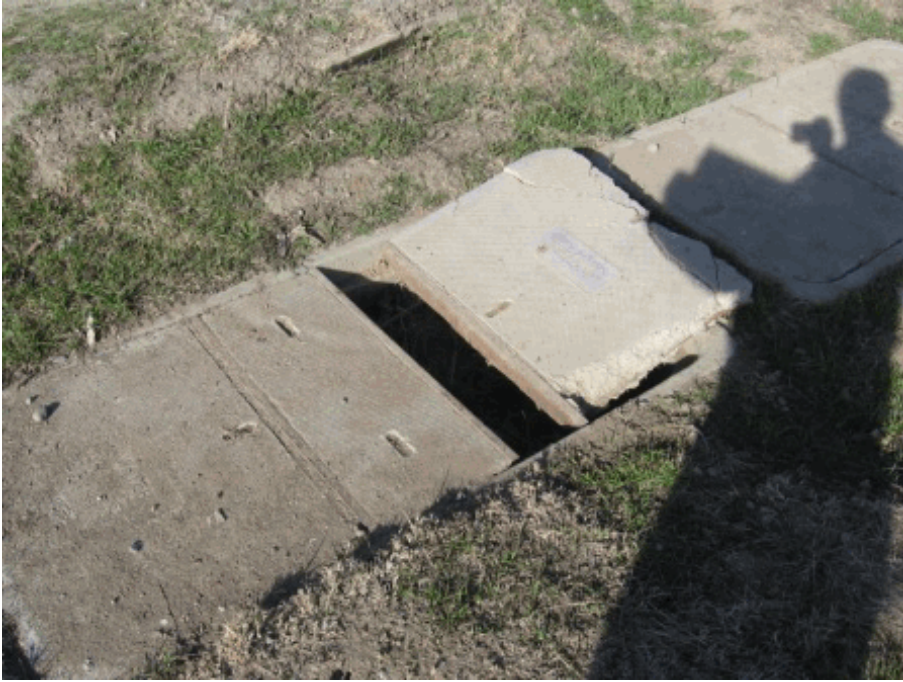
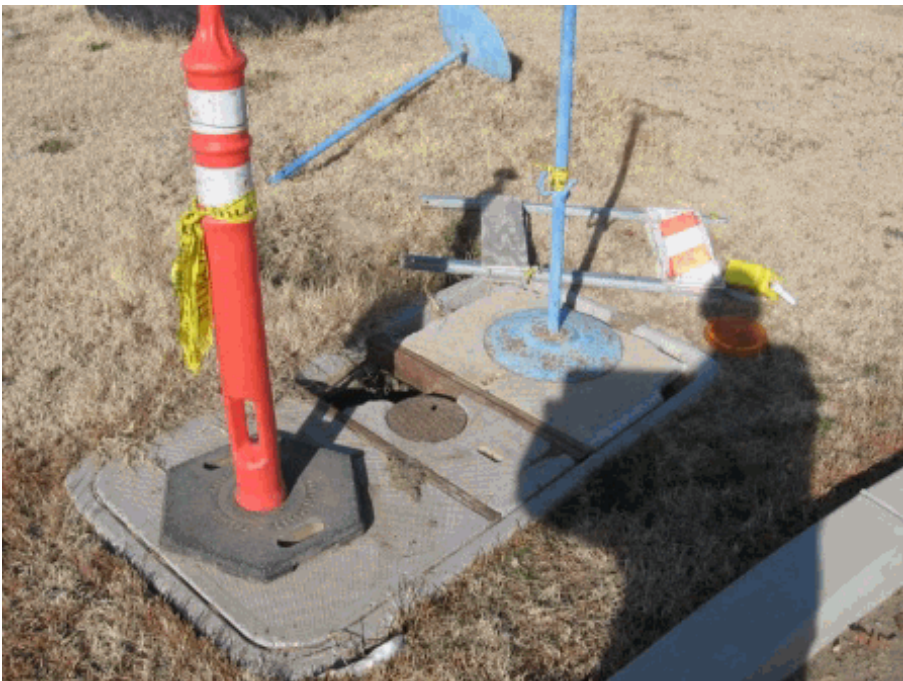
SPORTS FIELDS AND TRACK AREA

The fields near the metal (storage containers) has access to water shut off valve. The lid to the access covers is broken and presents a tripping hazard.

Priority: High

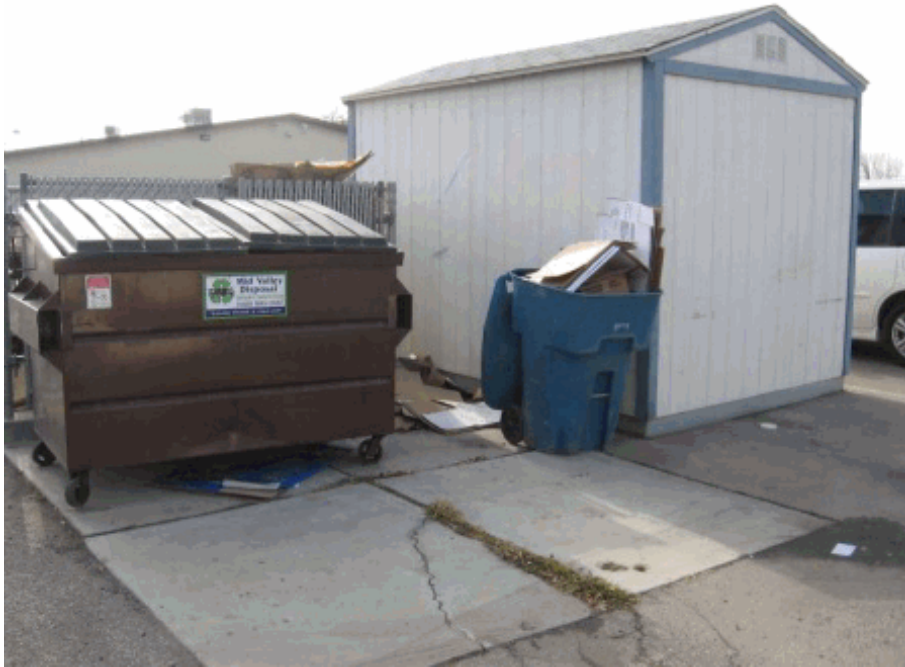
CDC - SCHOOL

Housekeeping should be improved near dumpster. The area should be kept in a clean and orderly condition. Dumpster should be moved away from shed.

Priority: High

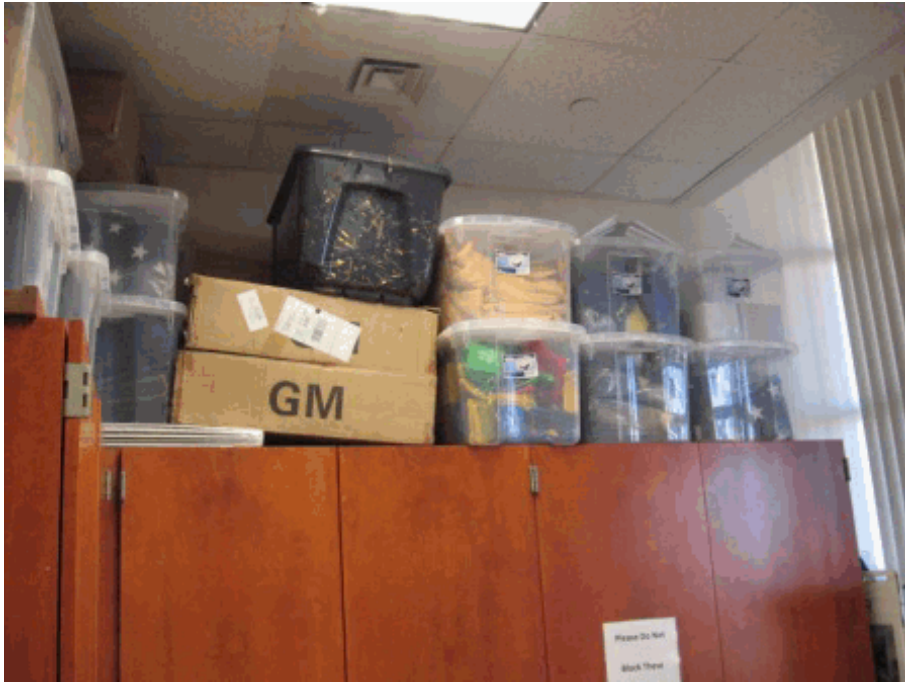
Bldg 110 - Storage area

Materials stored on top of cabinets or upper shelves created a falling object hazard. The materials should be secured or removed and stored at a lower level.

Category: General Safety
Priority: High

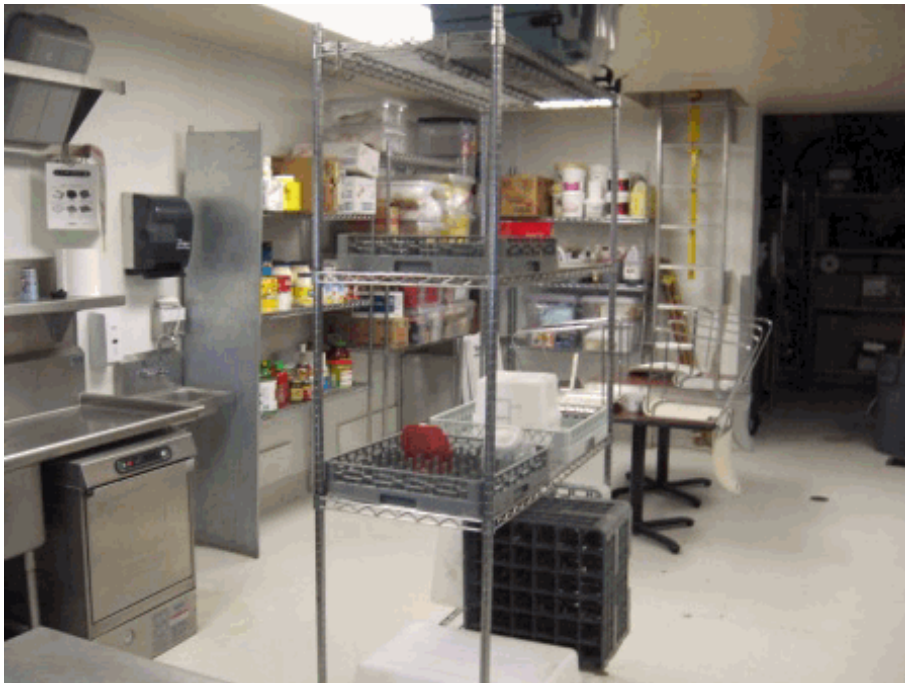
Culinary Arts Rm 841

Food storage cabinets should be secured to the wall, the floor or each other, or located so as to prevent them from tipping over and/or striking persons in the room.

Category: General Safety
Priority: High

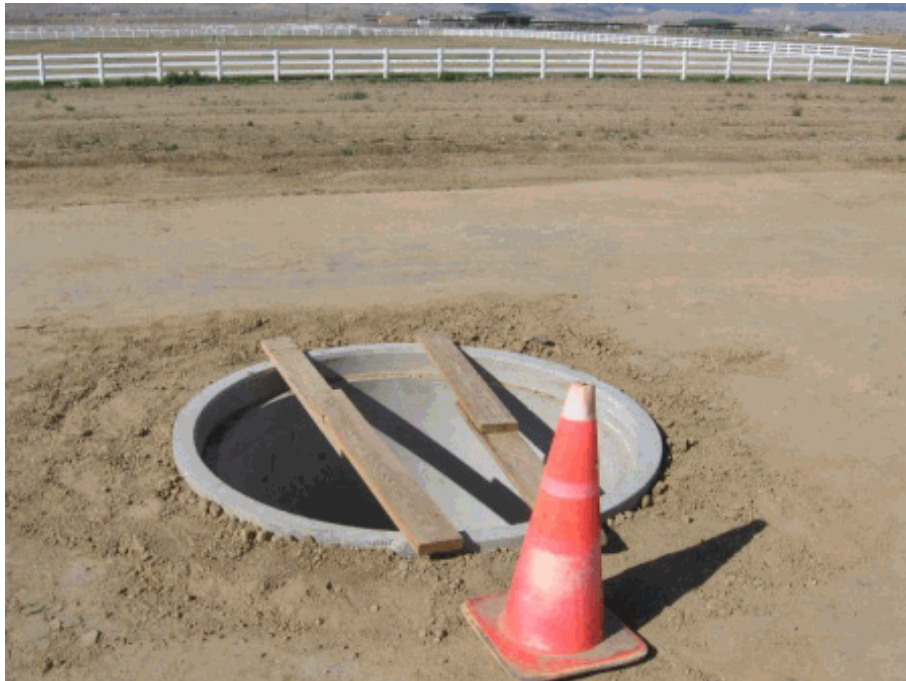
Water ponding area

Water ponding basin, under construction has concrete down well system and presents a fall hazard. Area needs warning signs and cover to prevent someone from falling.

Category: General Safety
Priority: High

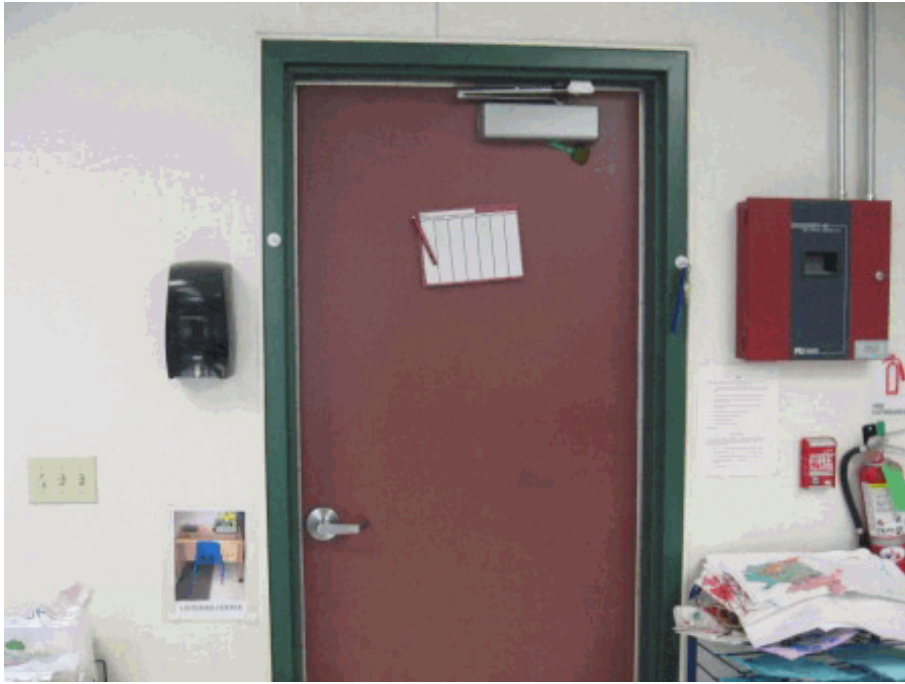
CDC

Exit doors were not properly marked for safe egress. All exits should be clearly marked.

Category: General Safety
Priority: High
